**Flood Control Project Maintenance
Levee Inspections**
LMA District Cover Sheet
Spring 2020 Levee Inspection Results

Lower San Joaquin Levee District

Spring 2020 Levee Inspection Results

Waterway			Bank	Unit Miles
Unit No. 01 San Joaquin River			Right	22.52
	Spring (March - May)	Summer (June - August)	(September - November) Fall	Winter (December - February)
Unit Maintenance Rating (Fall Only)				
Date of Inspection	4/21/2020 - 4/21/2020			
DWR Inspector	Corey Fujitani			
Accompanied By

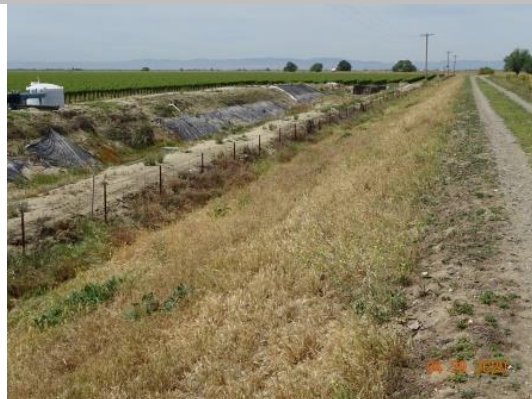
Photo 1 of 1 : SP_2020_NA0010_132_10_20200511_00011.jpg

LM Start	0.03	Rating **	M	Issue No.	10
LM End	1.24	Issue Type +	Ma	Location *	LS
Category	Earthen Levee			GPS Latitude/Longitude	
				Start	End
Item	Vegetation			37.032822 °	37.045311 °
				-120.441090 °	-120.428133 °
DWR ID	DWR_NA0010_14_s_2020_10				
Comment Code					
V1 : Control annual grass and weeds on the levee slopes and easements.					
Inspector Comment

View along the landside slope looking downstream. (Spring 2020)

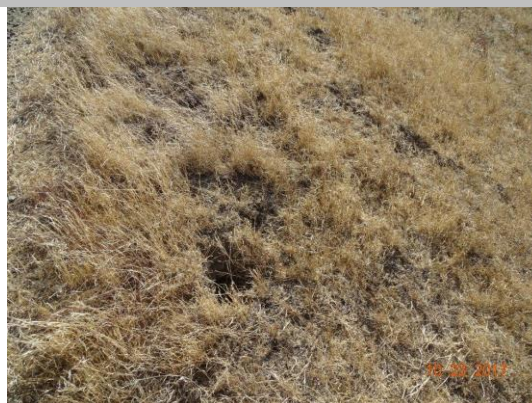
Photo 1 of 1 : SP_2020_NA0010_132_5_20200225_00001.jpg

LM Start	0.25	Rating **	M	Issue No.	5
LM End	0.25	Issue Type +	Ma	Location *	LS
Category	Earthen Levee			GPS Latitude/Longitude	
				Start	End
Item	Animal Control			37.035841 °	37.035841 °
				-120.439795 °	-120.439795 °
DWR ID	DWR_NA0010_14_f_2017_5				
Comment Code					
A3 : No rodents visible, but rodent burrows visible; need to backfill and compact or grout burrows.					
Inspector Comment

Looking at the landside slope.

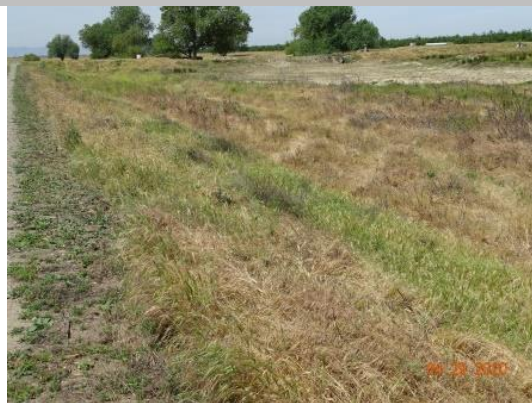
Photo 1 of 1 : SP_2020_NA0010_132_3_20200511_00012.jpg

LM Start	0.52	Rating **	U	Issue No.	3
LM End	1.25	Issue Type +	Ma	Location *	WS
Category	Earthen Levee			GPS Latitude/Longitude	
				Start	End
Item	Vegetation			37.039481 °	37.045364 °
				-120.438252 °	-120.427938 °
DWR ID	DWR_NA0010_14_s_2020_3				
Comment Code					
V1 : Control annual grass and weeds on the levee slopes and easements.					
Inspector Comment

Looking downstream along the waterside slope. (Spring 2020)

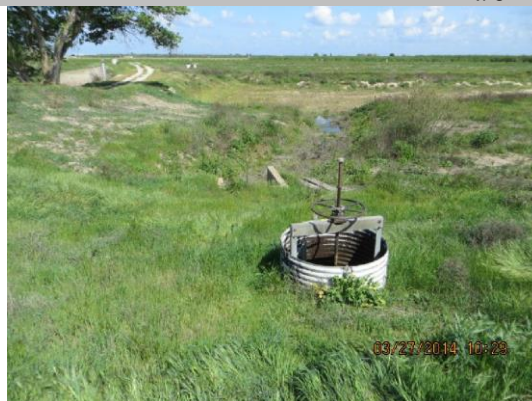
Photo 1 of 3 : UCIP_SP_2020_39526_59398.jpg

DS_ID:19909
FS_ID:39526
EP_NO: N/A
Repair Type: Non-Urgent
Crossing Status: Found
UCIP Comments: 03/27/2014 Lid should be installed on CMP riser on WS slope, could be a safety hazard. Also dense vegetation limits the inspector's visibility to identify signs of pipe failure (leaks) along the slope. Recommend removing vegetation along pipe alignment to conduct proper inspection of structure. (DWR UCIP - O. Magana)
FIELD_STRUCT_DESC: [Rounder Irrigation Structure] 36-inch corrugated metal gravity irrigation pipe through the levee, 10 feet below the crown. Slide gate in a 48-inch corrugated metal pipe (CMP) riser on the waterside (WS) slope. 6-foot by 7-foot concrete distribution box at the WS toe. Slots for wooden flashboards on the WS of the box. 7-foot by 9-foot concrete distribution box on the landside (LS), 20 feet from the toe. [Additional Reference(s): DWR Levee Log, 2002. USACE San Joaquin O&M Manual 601.1, 1967, (HLM 1.15)].

Slide gate in CMP riser and outlet/inlet structure visible in background at WS toe.

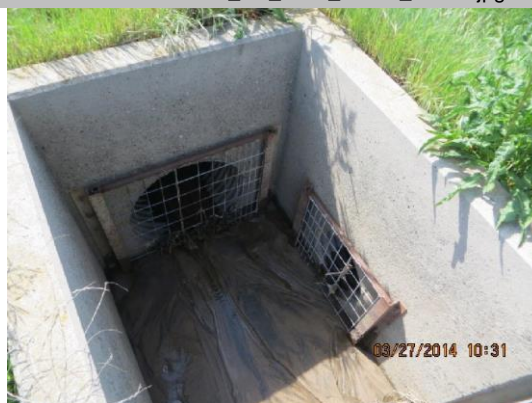
Photo 2 of 3 : UCIP_SP_2020_39526_59396.jpg

concrete inlet/outlet at WS toe.

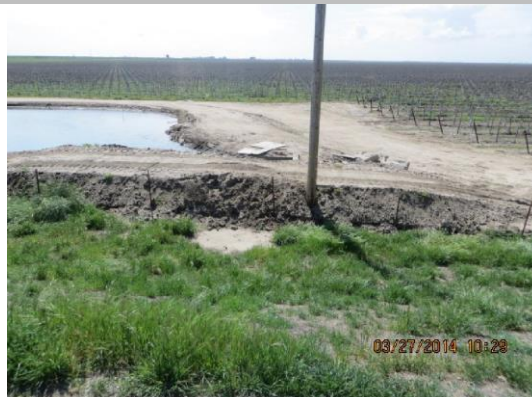
Photo 3 of 3 : UCIP_SP_2020_39526_59397.jpg

Concrete distribution box visible next to power pole off LS toe.

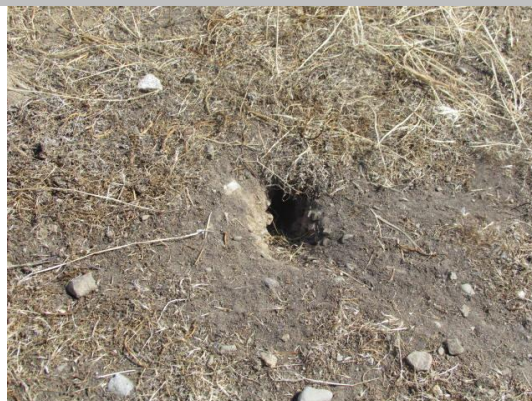
Photo 1 of 1 : SP_2020_NA0010_132_79_20200225_00004.jpg

LM Start	1.24	Rating **	M	Issue No.	79
LM End	1.24	Issue Type +	Ma	Location *	LS
Category	Earthen Levee			GPS Latitude/Longitude	
				Start	End
Item	Animal Control			37.045343 °	37.045343 °
				-120.428007 °	-120.428007 °
DWR ID	DWR_NA0010_14_s_2015_79				
Comment Code					
A3 : No rodents visible, but rodent burrows visible; need to backfill and compact or grout burrows.					
Inspector Comment					
Several rodent holes are noted on the landside at this location.

Looking at typical view of rodent holes on landward slope.

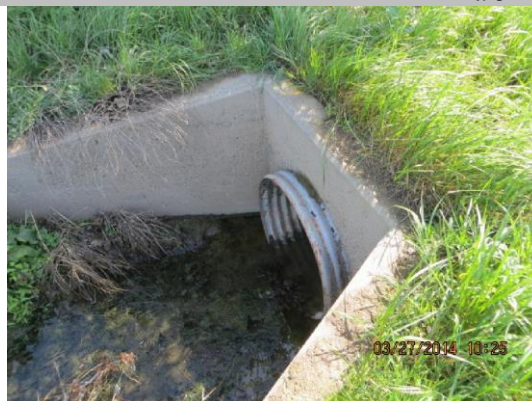
Photo 1 of 3 : UCIP_SP_2020_32828_59402.jpg

Concrete U-shaped headwall on Ws toe.

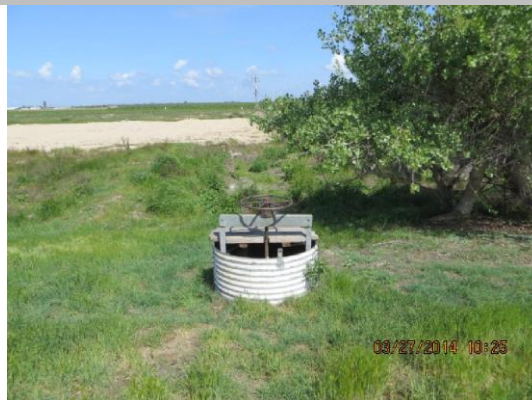
Photo 2 of 3 : UCIP_SP_2020_32828_59401.jpg

slidegate in CMP riser on WS slope.

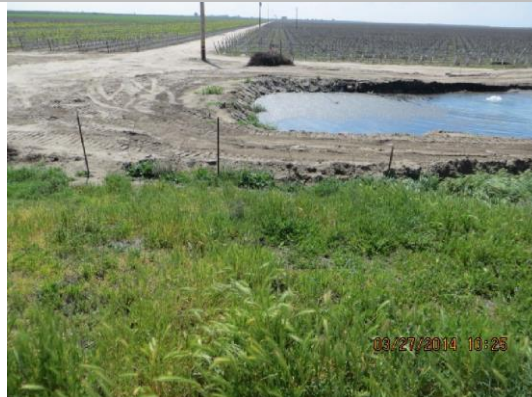
Photo 3 of 3 : UCIP_SP_2020_32828_59400.jpg

Inlet assumed to be within irrigation structure off LS toe.

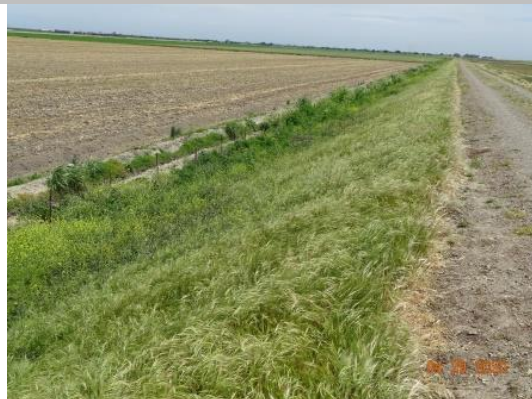
Photo 1 of 1 : SP_2020_NA0010_133_10_20200511_00014.jpg

LM Start	0.02	Rating **	U	Issue No.	10
LM End	2.01	Issue Type +	Ma	Location *	LS
Category	Earthen Levee			GPS Latitude/Longitude	
				Start	End
Item	Vegetation			36.996562 °	36.996603 °
				-120.410021 °	-120.374117 °
DWR ID	DWR_NA0010_15_s_2020_10				
Comment Code					
V1 : Control annual grass and weeds on the levee slopes and easements.					
Inspector Comment

View of the vegetation along the landside slope. (Spring 2020)

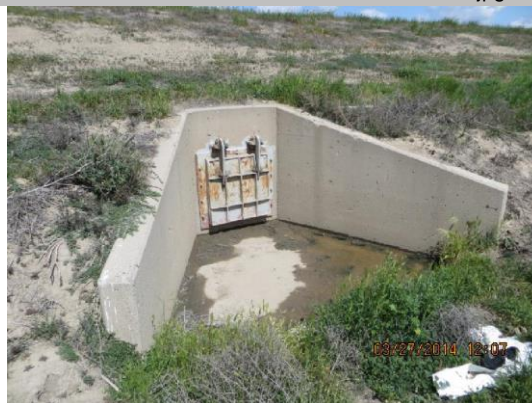
Photo 2 of 3 : UCIP_SP_2020_32838_59449.jpg

Flapgate on Concrete headwall at WS toe.

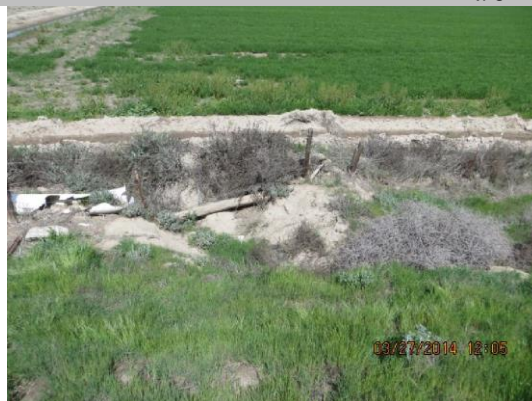
Photo 3 of 3 : UCIP_SP_2020_32838_59447.jpg

Concrete headwall on LS toe.

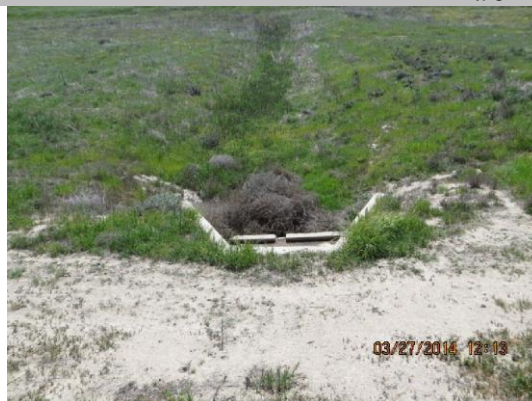
Photo 1 of 3 : UCIP_SP_2020_39527_59452.jpg

DS_ID:19912
 FS_ID:39527
 EP_NO: N/A
 Repair Type: Non-Urgent
 Crossing Status: Found
 UCIP Comments: 03/27/2014 Dense vegetation limits the inspector's visibility to identify signs of pipe failure (leaks) along the landward slope. Recommend removing vegetation along pipe alignment to conduct proper inspection of structure. (DWR UCIP - W. Wylie)
 FIELD_STRUCT_DESC: 30-inch by 30-inch square reinforced concrete box gravity drainage culvert through the levee, 8.5 feet below the crown. Flap gate on the waterside (WS) end. Concrete headwall on the landside (LS) end. Concrete U-shaped headwall on the WS end.
 [Additional Reference(s): DWR Levee Log, 2002. USACE San Joaquin O&M Manual 601.1, 1967, (HLM 1.01)].
 FS Date: 3/27/2014

Concrete headwall on WS toe.

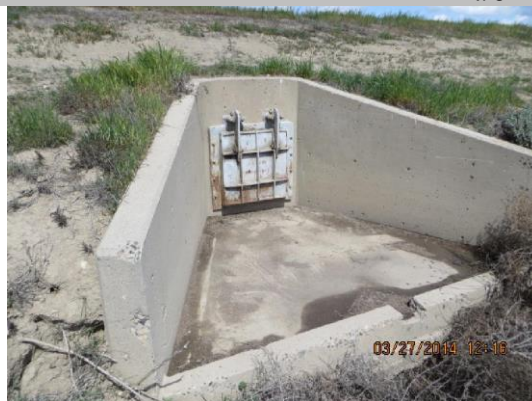
Photo 2 of 3 : UCIP_SP_2020_39527_59453.jpg

Flapgate on concrete headwall at WS toe.

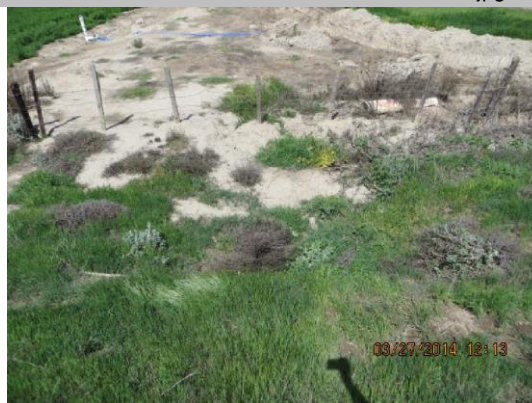
Photo 3 of 3 : UCIP_SP_2020_39527_59451.jpg

Concrete headwall on LS toe.

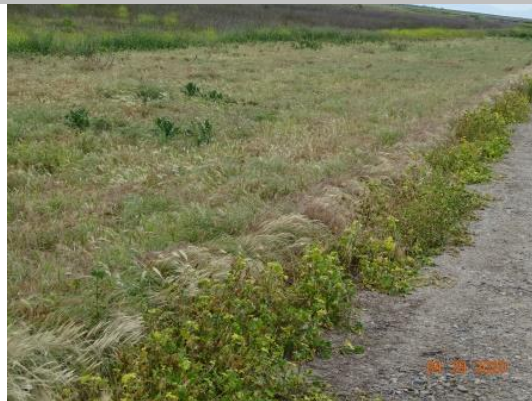
Photo 1 of 1 : SP_2020_NA0010_133_13_20200511_00015.jpg

LM Start	1.53	Rating **	U	Issue No.	13
LM End	2.01	Issue Type +	Ma	Location *	WS
Category	Earthen Levee			GPS Latitude/Longitude	
				Start	End
Item	Vegetation			36.996584 °	36.996602 °
				-120.382764 °	-120.374117 °
DWR ID	DWR_NA0010_15_s_2020_13				
Comment Code					
V1 : Control annual grass and weeds on the levee slopes and easements.					
Inspector Comment

Looking downstream along the waterside slope. (Spring 2020)

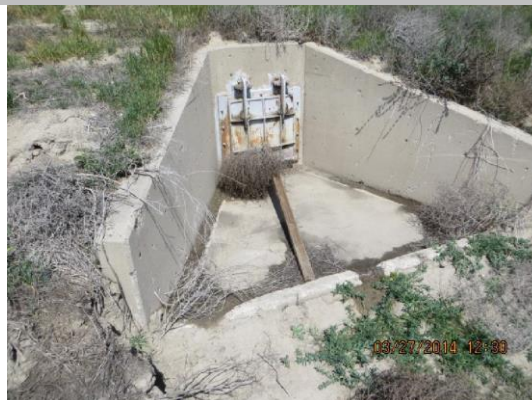
Photo 2 of 3 : UCIP_SP_2020_32840_59457.jpg

Flapgate on concrete headwall at WS toe.

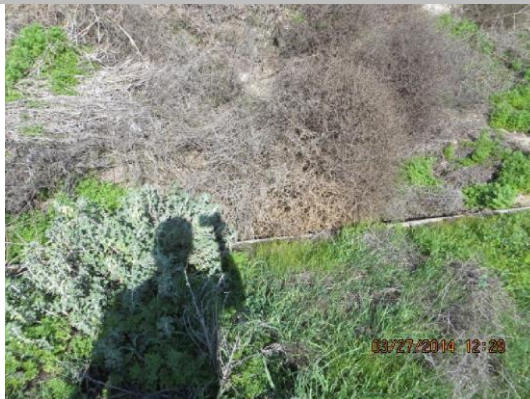
Photo 3 of 3 : UCIP_SP_2020_32840_59455.jpg

Concrete headwall on LS toe. Note excessive vegetation buildup.

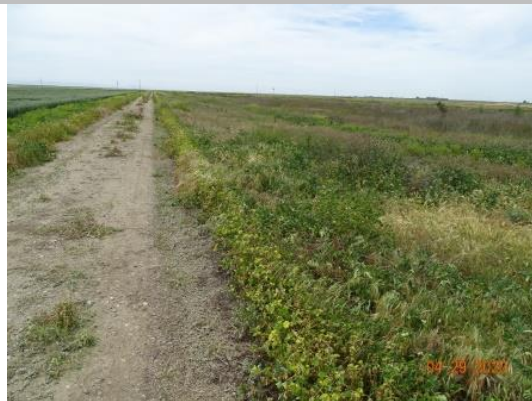
Photo 1 of 1 : SP_2020_NA0010_134_7_20200511_00011.jpg

LM Start	0.01	Rating **	U	Issue No.	7
LM End	1.95	Issue Type +	Ma	Location *	WS
Category	Earthen Levee			GPS Latitude/Longitude	
				Start	End
Item	Vegetation			36.995409 °	36.995507 °
				-120.408828 °	-120.373658 °
DWR ID	DWR_NA0010_16_s_2020_7				
Comment Code					
V1 : Control annual grass and weeds on the levee slopes and easements.					
Inspector Comment

View of vegetation on the waterside slope looking downstream. (Spring 2020)

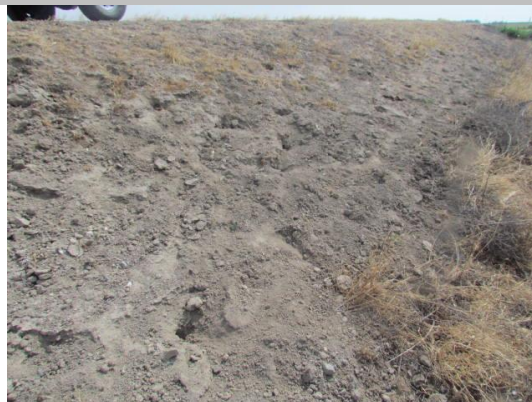
Photo 1 of 1 : SP_2020_NA0010_134_92_20200225_00006.jpg

LM Start	0.93	Rating **	M	Issue No.	92
LM End	0.93	Issue Type +	Ma	Location *	LS
Category	Earthen Levee			GPS Latitude/Longitude	
				Start	End
Item	Animal Control			36.995439 °	36.995439 °
				-120.392146 °	-120.392146 °
DWR ID	DWR_NA0010_16_s_2015_92				
Comment Code					
A3 : No rodents visible, but rodent burrows visible; need to backfill and compact or grout burrows.					
Inspector Comment					
Several rodent holes are identified within this section.

Looking at several rodent holes on landward slope.

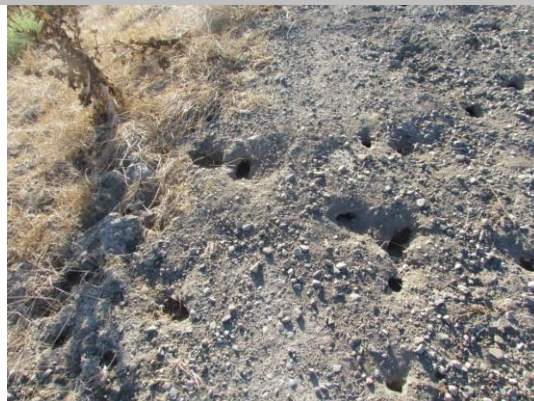
Photo 1 of 1 : SP_2020_NA0010_134_3_20200225_00003.jpg

LM Start	1.09	Rating **	M	Issue No.	3
LM End	1.09	Issue Type +	Ma	Location *	CR
Category	Earthen Levee			GPS Latitude/Longitude	
				Start	End
Item	Animal Control			36.995433 °	36.995433 °
				-120.389190 °	-120.389190 °
DWR ID	DWR_NA0010_16_f _ 2016_3				
Comment Code					
A3 : No rodents visible, but rodent burrows visible; need to backfill and compact or grout burrows.					
Inspector Comment					
Several rodent holes are identified on the levee crown.

Looking at several rodent holes and mole holes on levee crown.

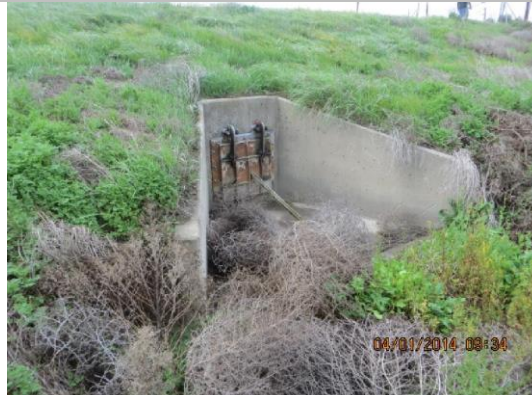
Photo 2 of 3 : UCIP_SP_2020_39529_59680.jpg

Flapgate on headwall at WS toe.

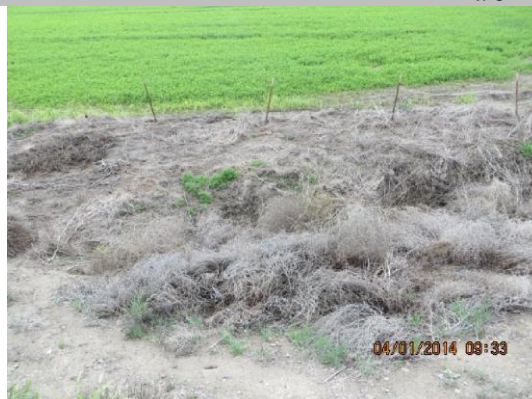
Photo 3 of 3 : UCIP_SP_2020_39529_59682.jpg

Concrete headwall on LS toe covered in vegetation/tumble weeds.

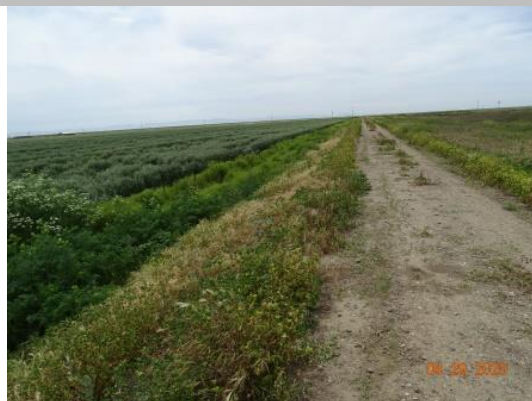
Photo 1 of 1 : SP_2020_NA0010_134_8_20200511_00013.jpg

LM Start	1.48	Rating **	U	Issue No.	8
LM End	1.95	Issue Type +	Ma	Location *	LS
Category	Earthen Levee			GPS Latitude/Longitude	
				Start	End
Item	Vegetation			36.995496 °	36.995508 °
				-120.382205 °	-120.373658 °
DWR ID	DWR_NA0010_16_s_2020_8				
Comment Code					
V1 : Control annual grass and weeds on the levee slopes and easements.					
Inspector Comment

Looking downstream along the landside. (Spring 2020)

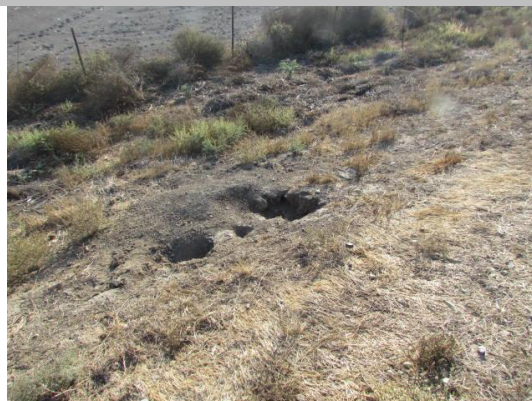
Photo 1 of 1 : SP_2020_NA0010_134_2_20200225_00002.jpg

LM Start	1.77	Rating **	U	Issue No.	2
LM End	1.77	Issue Type +	Ma	Location *	LS
Category	Earthen Levee			GPS Latitude/Longitude	
				Start	End
Item	Animal Control			36.995487 °	36.995487 °
				-120.377054 °	-120.377054 °
DWR ID	DWR_NA0010_16_f_2014_2				
Comment Code					
A3 : No rodents visible, but rodent burrows visible; need to backfill and compact or grout burrows.					
Inspector Comment					
Large rodent holes are on the landside slope.

Looking southwest at several rodent holes on landward slope.

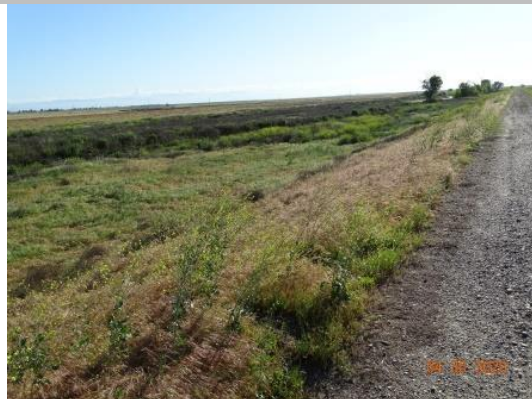
Photo 1 of 1 : SP_2020_NA0010_135_16_20200511_00040.jpg

LM Start	0.00	Rating **	U	Issue No.	16
LM End	2.34	Issue Type +	Ma	Location *	LS
Category	Earthen Levee			GPS Latitude/Longitude	
				Start	End
Item	Vegetation			36.976451 °	36.955250 °
				-120.374719 °	-120.350677 °
DWR ID	DWR_NA0010_17_s_2020_16				
Comment Code					
V1 : Control annual grass and weeds on the levee slopes and easements.					
Inspector Comment

View of vegetation on the landside slope looking upstream. (Spring 2020)

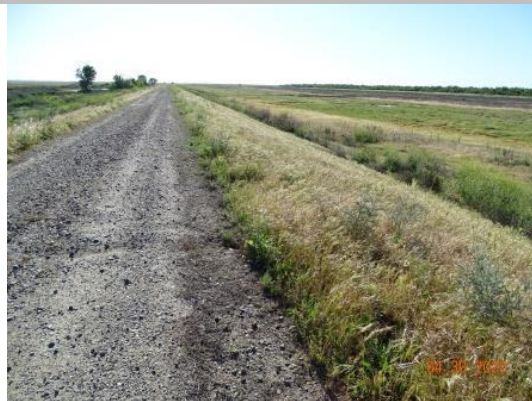
Photo 1 of 1 : SP_2020_NA0010_135_17_20200512_00041.jpg

LM Start	0.03	Rating **	U	Issue No.	17
LM End	1.99	Issue Type +	Ma	Location *	WS
Category	Earthen Levee			GPS Latitude/Longitude	
				Start	End
Item	Vegetation			36.976451 °	36.959763 °
				-120.374265 °	-120.353467 °
DWR ID	DWR_NA0010_17_s_2020_17				
Comment Code					
V1 : Control annual grass and weeds on the levee slopes and easements.					
Inspector Comment

View of the waterside slope looking upstream. (Spring 2020)

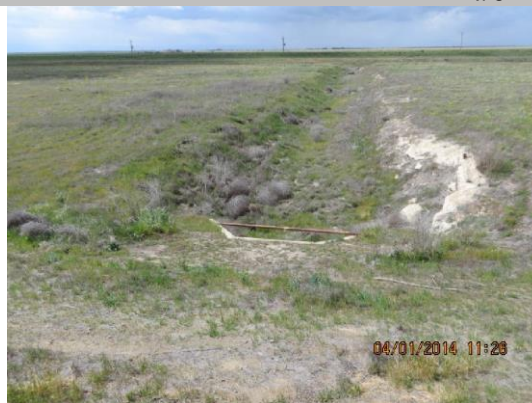
Photo 1 of 3 : UCIP_SP_2020_39531_59710.jpg

Comment Code						
Inspector Comment						
DS_ID:19916 FS_ID:39531 EP_NO: N/A Repair Type: Non-Urgent Crossing Status: Found UCIP Comments: 04/01/2014 Dense vegetation limits the inspector's visibility to identify signs of pipe failure (leaks) along the landward slope. Recommend removing vegetation along pipe alignment to conduct proper inspection of structure. (DWR UCIP - W. Wylie) FIELD_STRUCT_DESC: 48-inch by 60-inch reinforced concrete box gravity drainage culvert through the levee, 14.6 feet below the crown. Flap gate on the waterside (WS) end. Concrete headwall on the landside (LS) end. Concrete U-shaped headwall on the WS end. [Additional Reference(s): DWR Levee Log, 2002. USACE San Joaquin O&M Manual 601.1, 1967, (HLM 2.58)]. FS Date: 4/1/2014

Concrete headwall at channel on WS toe.

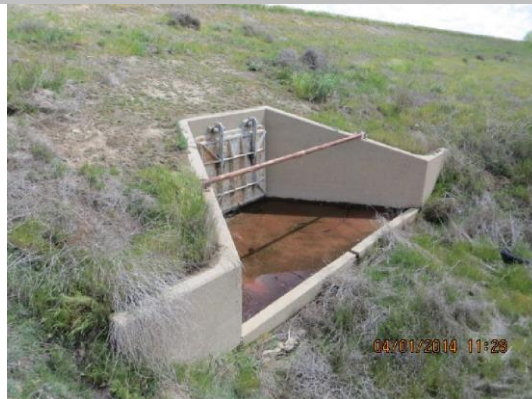
Photo 2 of 3 : UCIP_SP_2020_39531_59711.jpg

Flapgate on Concrete headwall at WS toe.

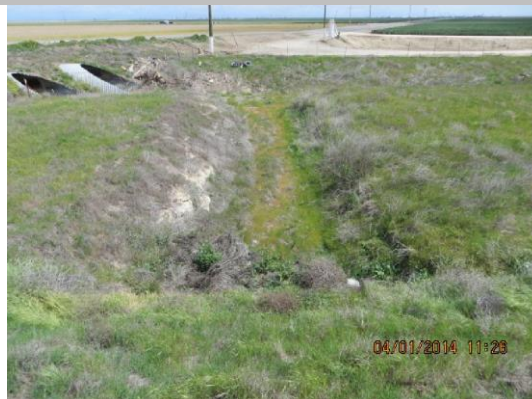
Photo 3 of 3 : UCIP_SP_2020_39531_59709.jpg

Concrete headwall at LS toe.

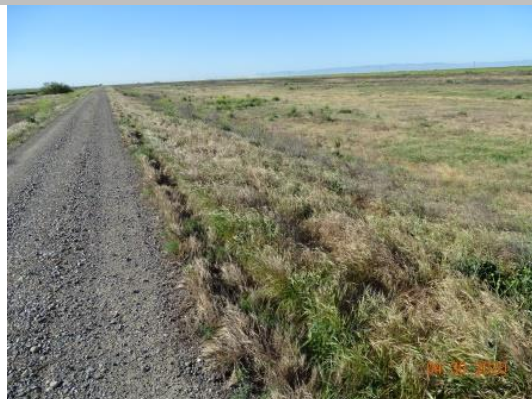
Photo 1 of 1 : SP_2020_NA0010_135_30_20200512_00042.jpg

LM Start	3.50	Rating **	U	Issue No.	30
LM End	4.13	Issue Type +	Ma	Location *	WS
Category	Earthen Levee			GPS Latitude/Longitude	
				Start	End
Item	Vegetation			36.939838 °	36.931046 °
				-120.342598 °	-120.339362 °
DWR ID	DWR_NA0010_17_s_2020_30				
Comment Code					
V1 : Control annual grass and weeds on the levee slopes and easements.					
Inspector Comment

Looking upstream along the waterside slope. (Spring 2020)

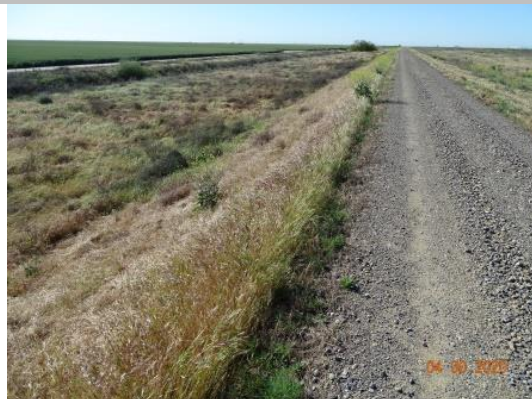
Photo 1 of 1 : SP_2020_NA0010_135_29_20200512_00043.jpg

LM Start	3.50	Rating **	U	Issue No.	29
LM End	4.48	Issue Type +	Ma	Location *	LS
Category	Earthen Levee			GPS Latitude/Longitude	
				Start	End
Item	Vegetation			36.939838 °	36.926206 °
				-120.342598 °	-120.337588 °
DWR ID	DWR_NA0010_17_s_2020_29				
Comment Code					
V1 : Control annual grass and weeds on the levee slopes and easements.					
Inspector Comment

Looking at vegetation on the landside slope. (Spring 2020)

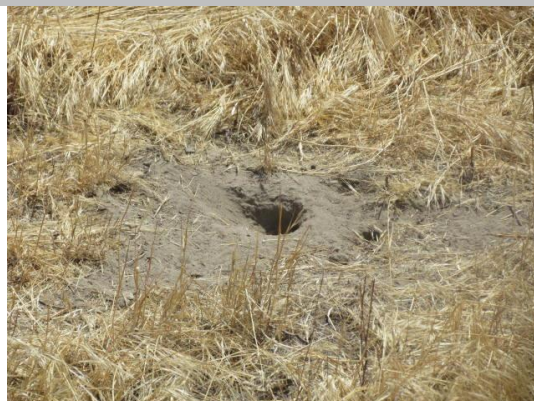
Photo 1 of 1 : SP_2020_NA0010_135_4_20200225_00003.jpg

LM Start	6.51	Rating **	M	Issue No.	4
LM End	6.72	Issue Type +	Ma	Location *	LS
Category	Earthen Levee			GPS Latitude/Longitude	
				Start	End
Item	Animal Control			36.898093 °	36.895300 °
				-120.326689 °	-120.325322 °
DWR ID	DWR_NA0010_17_s_2012_4				
Comment Code					
A1 : Exterminate rodents and backfill and compact or grout burrows.					
Inspector Comment					
Several rodent holes are identified within this reach.

Looking at typical view of rodent holes on landward slope.

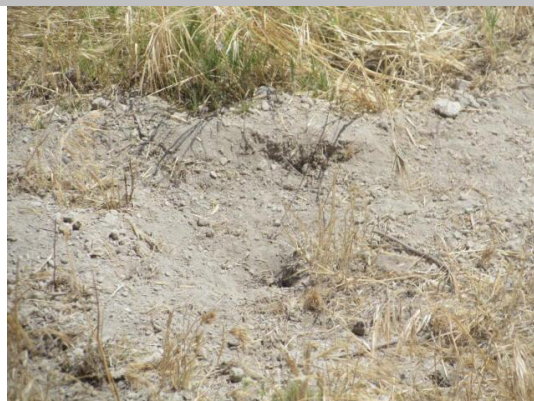
Photo 1 of 1 : SP_2020_NA0010_135_5_20200225_00004.jpg

LM Start	7.27	Rating **	M	Issue No.	5
LM End	7.38	Issue Type +	Ma	Location *	LS
Category	Earthen Levee			GPS Latitude/Longitude	
				Start	End
Item	Animal Control			36.887852 °	36.886388 °
				-120.321668 °	-120.320950 °
DWR ID	DWR_NA0010_17_s_2012_5				
Comment Code					
A3 : No rodents visible, but rodent burrows visible; need to backfill and compact or grout burrows.					
Inspector Comment					
Several rodent holes are identified within this reach.

Looking at typical view of rodent holes on landward slope.

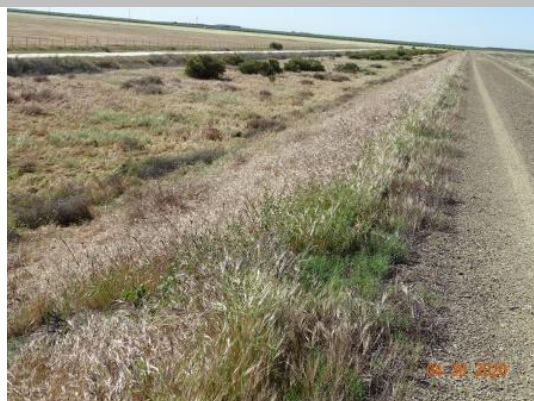
Photo 1 of 1 : SP_2020_NA0010_135_33_20200512_00045.jpg

LM Start	7.31	Rating **	U	Issue No.	33
LM End	8.47	Issue Type +	Ma	Location *	LS
Category	Earthen Levee			GPS Latitude/Longitude	
				Start	End
Item	Vegetation			36.887329 °	36.871029 °
				-120.321419 °	-120.316929 °
DWR ID	DWR_NA0010_17_s_2020_33				
Comment Code					
V1 : Control annual grass and weeds on the levee slopes and easements.					
Inspector Comment

View of vegetation on the landside slope. (Spring 2020)

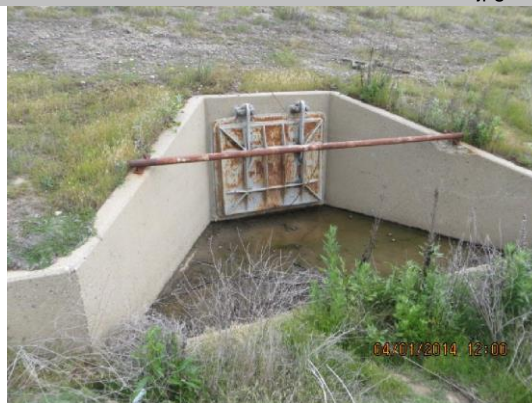
Photo 2 of 3 : UCIP_SP_2020_32999_59720.jpg

Flapgate on concrete headwall at WS toe.

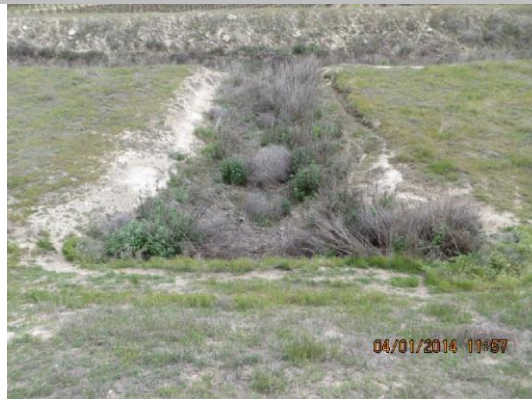
Photo 3 of 3 : UCIP_SP_2020_32999_59719.jpg

Concrete headwall and channel on LS toe.

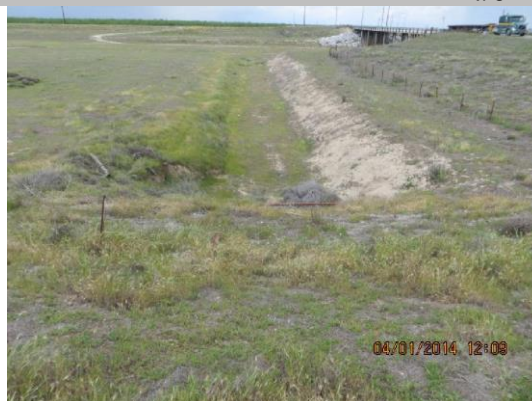
Photo 1 of 3 : UCIP_SP_2020_39532_59723.jpg

Comment Code						
Inspector Comment						
DS_ID:19917 FS_ID:39532 EP_NO: N/A Repair Type: Non-Urgent Crossing Status: Found UCIP Comments: 04/01/2014 Dense vegetation limits the inspector's visibility to identify signs of pipe failure (leaks) along the landward slope. Recommend removing vegetation along pipe alignment to conduct proper inspection of structure. (DWR UCIP - W. Wylie) FIELD_STRUCT_DESC: 48-inch by 60-inch reinforced concrete box gravity drainage culvert through the levee, 15 feet below the crown. Concrete headwall on the landside (LS) end. Concrete U-shaped headwall on the waterside (WS) end. [Additional Reference(s): DWR Levee Log, 2002. USACE San Joaquin O&M Manual 601.1, 1967, (HLM 9.89)]. FS Date: 4/1/2014

Concrete headwall and channel on WS toe.

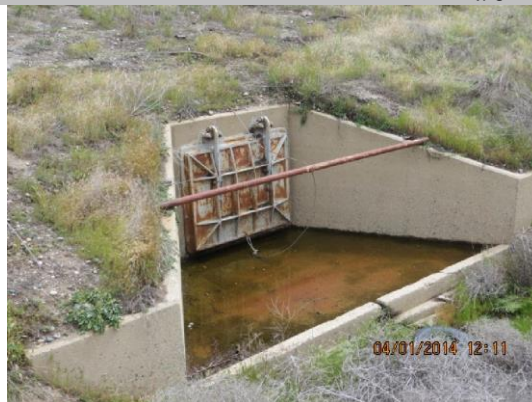
Photo 2 of 3 : UCIP_SP_2020_39532_59724.jpg

Flapgate on Concrete headwall at WS toe.

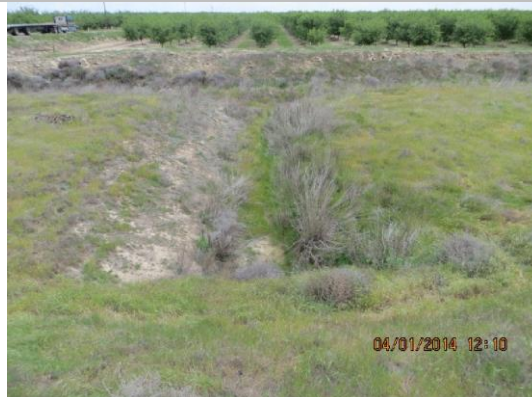
Photo 3 of 3 : UCIP_SP_2020_39532_59722.jpg

Concrete headwall and channel on LS toe.

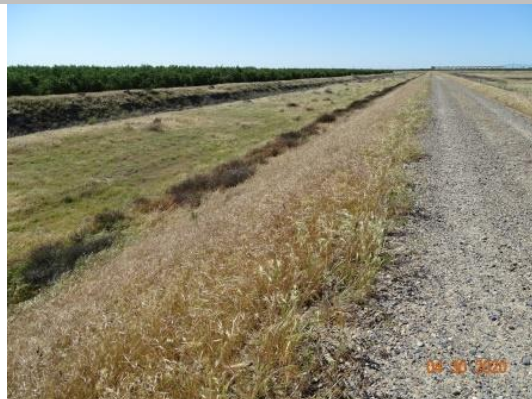
Photo 1 of 1 : SP_2020_NA0010_135_36_20200512_00046.jpg

LM Start	9.93	Rating **	U	Issue No.	36
LM End	12.97	Issue Type +	Ma	Location *	LS
Category	Earthen Levee			GPS Latitude/Longitude	
				Start	End
Item	Vegetation			36.849973 °	36.811811 °
				-120.314127 °	-120.304266 °
DWR ID	DWR_NA0010_17_s_2020_36				
Comment Code					
V1 : Control annual grass and weeds on the levee slopes and easements.					
Inspector Comment

Looking upstream at vegetation on the landside slope. (Spring 2020)

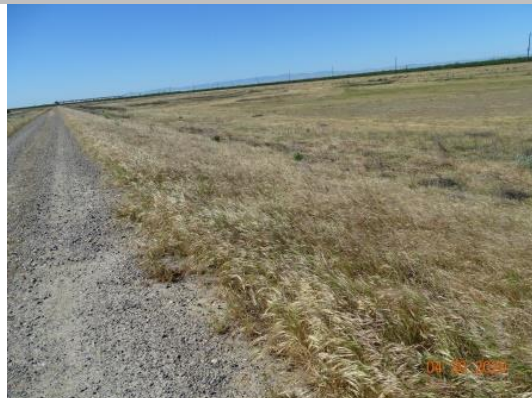
Photo 1 of 1 : SP_2020_NA0010_135_37_20200512_00047.jpg

LM Start	9.93	Rating **	U	Issue No.	37
LM End	16.01	Issue Type +	Ma	Location *	WS
Category	Earthen Levee			GPS Latitude/Longitude	
				Start	End
Item	Vegetation			36.849973 °	36.775336 °
				-120.314127 °	-120.284515 °
DWR ID	DWR_NA0010_17_s_2020_37				
Comment Code					
V1 : Control annual grass and weeds on the levee slopes and easements.					
Inspector Comment

View of vegetation on the waterside slope. (Spring 2020)

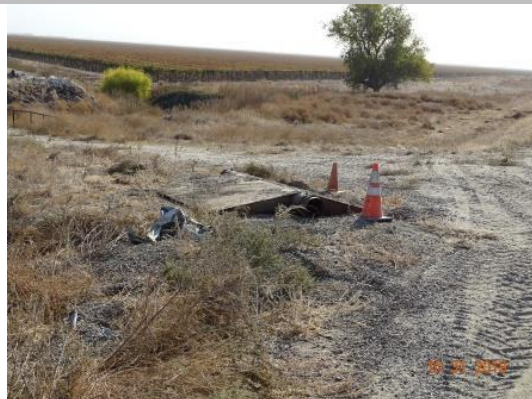
Photo 1 of 2 : SP_2020_NA0010_135_35_20200225_00014.jpg

LM Start	11.03	Rating **	A/W	Issue No.	35
LM End	11.03	Issue Type +	En	Location *	CR
Category	Earthen Levee			GPS Latitude/Longitude	
				Start	End
Item	Encroachments			36.836724 °	36.836724 °
				-120.305328 °	-120.305328 °
DWR ID	DWR_NA0010_17_f_2018_35				
Comment Code					
PI : Pipe					
Inspector Comment					
Temporary pipe and ramp were moved off the levee crown in Fall 2019 and are currently being stored on the waterside slope.

View of ramp and temporary pipe material left on the waterside slope. (Fall 2019)

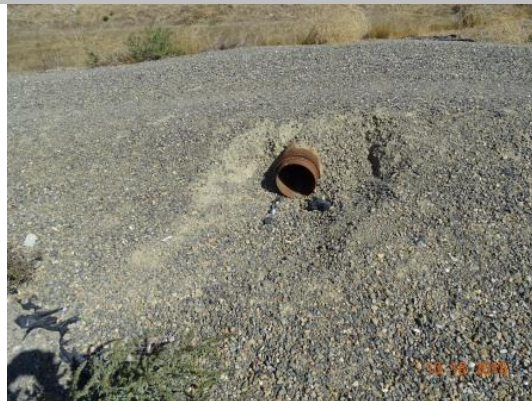
Photo 2 of 2 : SP_2020_NA0010_135_35_20200225_00016.jpg

LM Start	11.03	Rating **	A/W	Issue No.	35 (cont)
LM End	11.03	Issue Type +	En	Location *	CR

View of pipe encroachment looking across crown. (Fall 2018)

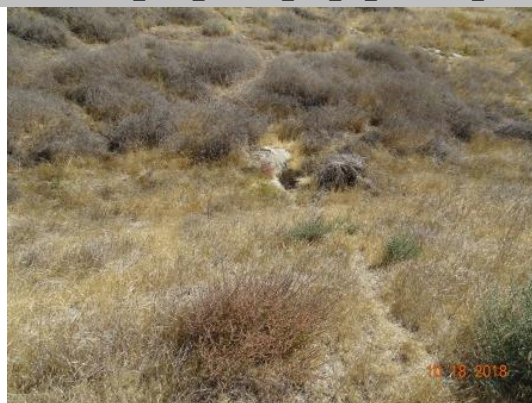
Photo 1 of 1 : SP_2020_NA0010_135_39_20200225_00017.jpg

LM Start	12.17	Rating **	U	Issue No.	39
LM End	12.17	Issue Type +	Ma	Location *	LS
Category	Earthen Levee			GPS Latitude/Longitude	
				Start	End
Item	Animal Control			36.822818 °	36.822818 °
				-120.299680 °	-120.299680 °
DWR ID	DWR_NA0010_17_f _ 2018_39				
Comment Code					
A3 : No rodents visible, but rodent burrows visible; need to backfill and compact or grout burrows.					
Inspector Comment					
A large hole is on the landside toe.

Large rodent hole at toe of levee. (Fall 2018)

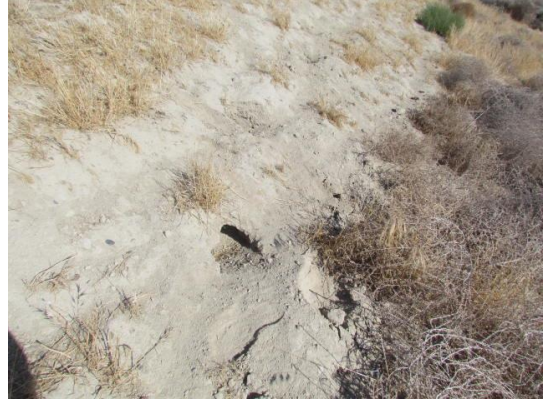
Photo 1 of 1 : SP_2020_NA0010_135_3_20200225_00001.jpg

LM Start	12.28	Rating **	M	Issue No.	3
LM End	12.38	Issue Type +	Ma	Location *	LS
Category	Earthen Levee			GPS Latitude/Longitude	
				Start	End
Item	Animal Control			36.821368 °	36.820000 °
				-120.300283 °	-120.300831 °
DWR ID	DWR_NA0010_17_s_2014_3				
Comment Code					
A3 : No rodents visible, but rodent burrows visible; need to backfill and compact or grout burrows.					
Inspector Comment					
Several rodent holes are identified within this reach.

Looking at typical view of rodent holes on landward slope. Fall 2015

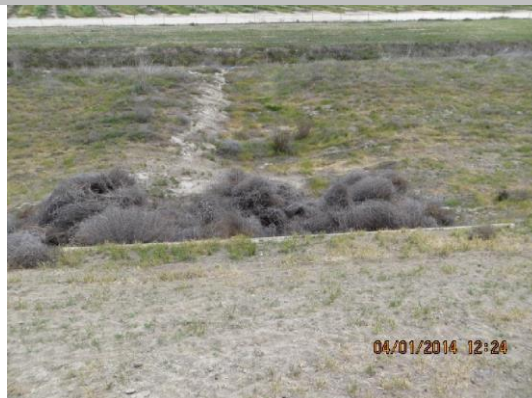
Photo 2 of 3 : UCIP_SP_2020_39533_59726.jpg

Concrete headwall on LS toe.

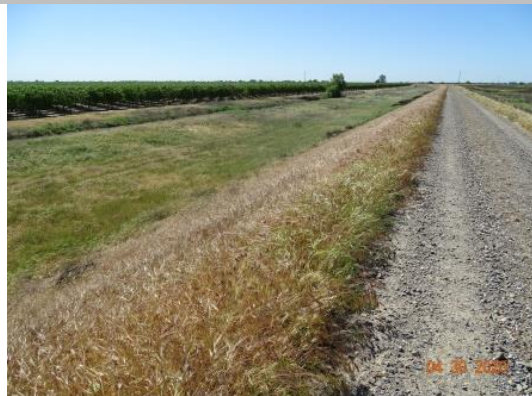
Photo 1 of 1 : SP_2020_NA0010_135_40_20200512_00048.jpg

LM Start	13.65	Rating **	U	Issue No.	40
LM End	16.01	Issue Type +	Ma	Location *	LS
Category	Earthen Levee			GPS Latitude/Longitude	
				Start	End
Item	Vegetation			36.802510 °	36.775400 °
				-120.306992 °	-120.284567 °
DWR ID	DWR_NA0010_17_s_2020_40				
Comment Code					
V1 : Control annual grass and weeds on the levee slopes and easements.					
Inspector Comment

Looking upstream along the landside slope. (Spring 2020)

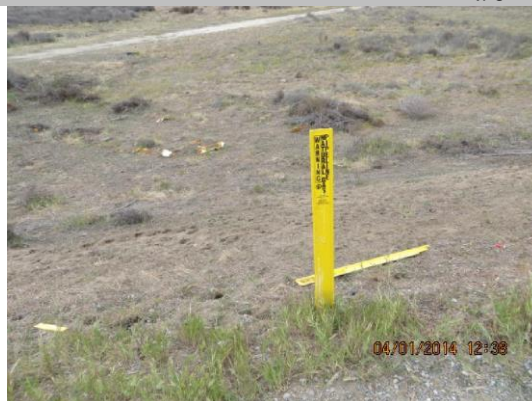
Photo 1 of 3 : UCIP_SP_2020_41406_71490.jpg

LM Start	14.38	Rating **	M	Issue No.	45	
LM End	14.38	Issue Type +	En	Location *		
Category	Supplemental			GPS Latitude/Longitude		
				Start	End	
Item	DWR UCIP Field Study			36.793318 °	36.793318 °	
				-120.302138 °	-120.302138 °	
DWR ID	24850					
Comment Code						
Inspector Comment						
DS_ID:24850						
FS_ID:41406						
EP_NO: N/A						
Repair Type: Non-Urgent						
Crossing Status: Indicator Found						
UCIP Comments: 04/01/2014 No permit identified for this crossing.						
(DWR UCIP - W. Wylie)						
FIELD_STRUCT_DESC: Natural gas pipeline of an unknown size or material through the levee, at an unknown depth. Gas line markers on both shoulders.						
FS Date: 4/1/2014

Gasline marker on WS slope..

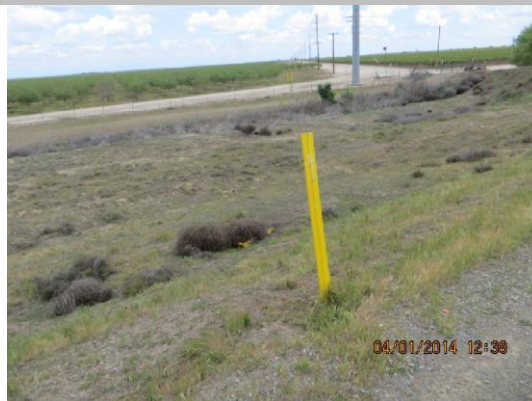
Photo 2 of 3 : UCIP_SP_2020_41406_71489.jpg

Gasline marker on LS shoulder.

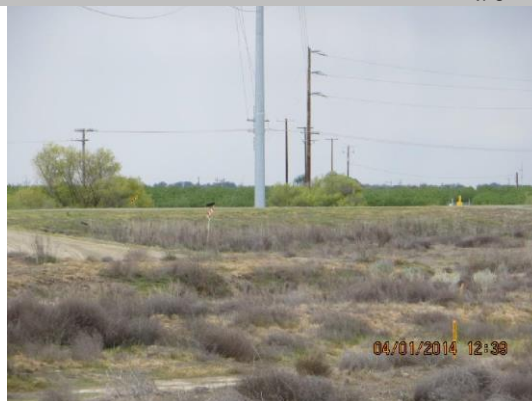
Photo 3 of 3 : UCIP_SP_2020_41406_71488.jpg

Gasline markers visible along right side of photo.

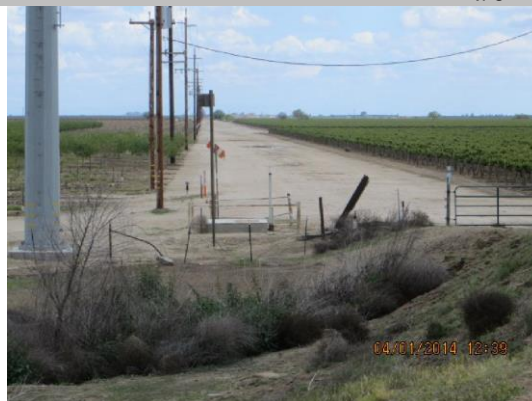
Photo 1 of 3 : UCIP_SP_2020_50067_59742.jpg

DS_ID:19562
 FS_ID:50067
 EP_NO: 18568
 Repair Type: Non-Urgent
 Crossing Status: Indicator Found
 UCIP Comments: 7/20/2016 Marker visible on LS. WS marker missing.
 (DWR UCIP - omagana)4/01/2014 Need to contact owner to confirm
 and obtain status of crossing. Markers misleading--unable to confirm if
 markers correspond to this crossing. Need markers at levee. (DWR
 UCIP - wwylie)
 FIELD_STRUCT_DESC: 30-inch coated steel natural gas pipeline
 through the levee, approximately 60 feet below the crown. Gas line
 markers are visible on the waterside (WS) and the landside (LS). (30-
 inch horizontal directional bore (HDD) authorized under Permit No.
 18568, 2010 - Gill Ranch Storage, LLC).
 FS Date: 7/20/2016

Gasline marker and concrete sump off LS toe.

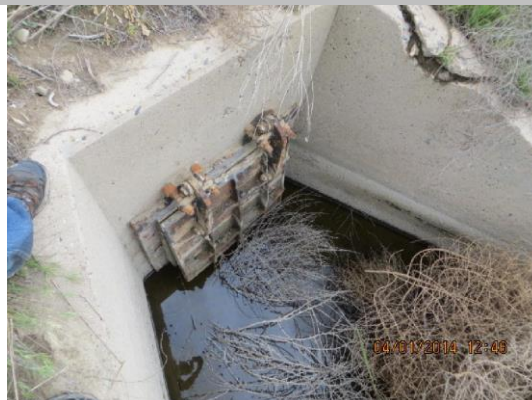
Photo 2 of 3 : UCIP_SP_2020_39535_59747.jpg

Flapgate on Concrete headwall at WS toe.

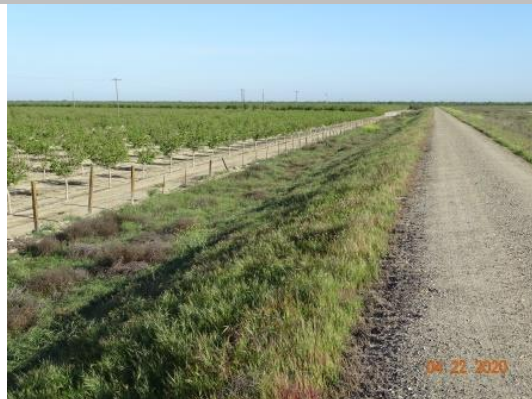
Photo 1 of 1 : SP_2020_NA0010_137_5_20200512_00032.jpg

LM Start	0.02	Rating **	U	Issue No.	5
LM End	1.33	Issue Type +	Ma	Location *	LS
Category	Earthen Levee			GPS Latitude/Longitude	
				Start	End
Item	Vegetation			36.973996 °	36.957500 °
				-120.363078 °	-120.354511 °
DWR ID	DWR_NA0010_18_s_2020_5				
Comment Code					
V1 : Control annual grass and weeds on the levee slopes and easements.					
Inspector Comment

View of the landside slope looking downstream. (Spring 2020)

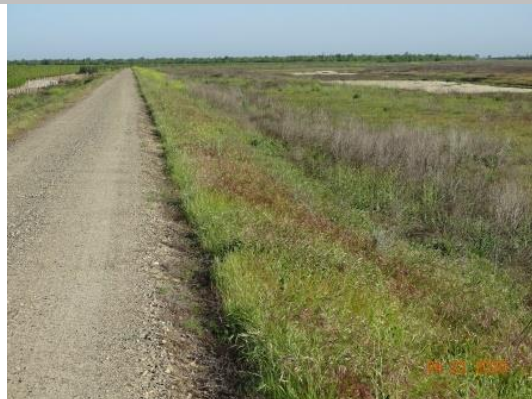
Photo 1 of 1 : SP_2020_NA0010_137_40_20200512_00033.jpg

LM Start	0.02	Rating **	U	Issue No.	40
LM End	1.33	Issue Type +	Ma	Location *	WS
Category	Earthen Levee			GPS Latitude/Longitude	
				Start	End
Item	Vegetation			36.973996 °	36.957500 °
				-120.363078 °	-120.354511 °
DWR ID	DWR_NA0010_18_s_2020_40				
Comment Code					
V1 : Control annual grass and weeds on the levee slopes and easements.					
Inspector Comment

Looking downstream along the waterside slope. (Spring 2020)

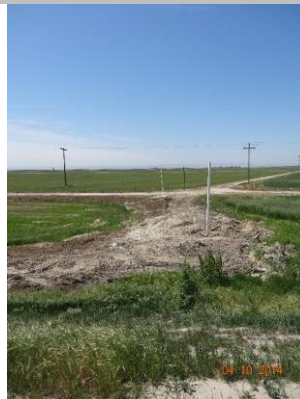
Photo 1 of 3 : UCIP_SP_2020_49968_60558.jpg

DS_ID:19926
FS_ID:49968
EP_NO: 6603
Repair Type: Non-Urgent
Crossing Status: Found
UCIP Comments: 7/20/2016 High burrow activity. Dense vegetation limits the inspector's visibility to identify signs of pipe failure (leaks) along the WS and LS slope. Recommend removing vegetation along pipe alignment to conduct proper inspection of structure and appurtenances. (DWR UCIP - omagana)4/10/2014 Subsidence present along pipe alignment on landward side. Modified crossing--worked done on landward side. Need to contact owner to determine permit authorizing work. Dense vegetation on landward side--tall grass. Pipe wall cut and new pipe sleeved on landward side. (DWR UCIP - omagana)
FIELD_STRUCT_DESC: 15-inch steel irrigation discharge pipe and electrical conduit through the levee, 3.7 feet below the crown. Siphon breaker on the landside (LS) shoulder. 36-inch concrete standpipe on the LS berm. Inlet facility on the riverbank, consisting of a pump, a 42-inch concrete standpipe, and a 20-inch concrete channel with an intake pipe and a cutoff wall. (Plans to install a pump and outlet pipe at two locations on the left bank levee of the Chowchilla Bypass authorized under Permit No. 6603, 1969 - Raymond N. Costales). [Additional Reference(s): DWR Levee Log, 2002].

Overview of LS--site modified.

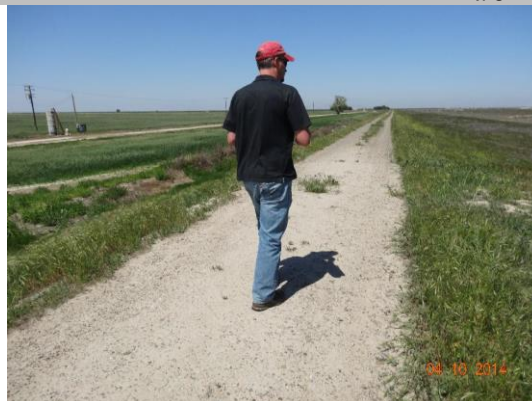
Photo 2 of 3 : UCIP_SP_2020_49968_60559.jpg

View of levee crown at crossing.

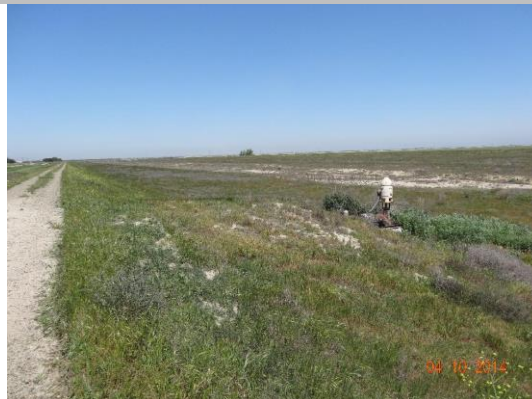
Photo 3 of 3 : UCIP_SP_2020_49968_60560.jpg

View of WS.

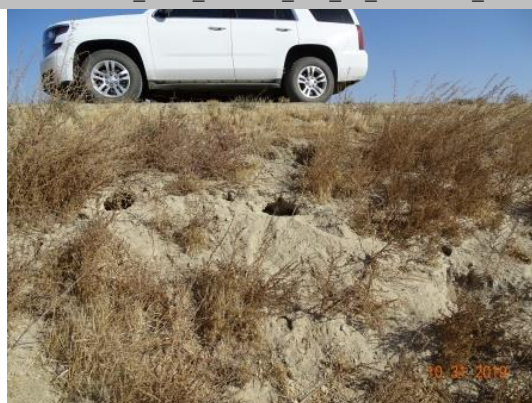
Photo 1 of 1 : SP_2020_NA0010_137_31_20200225_00015.jpg

LM Start	3.44	Rating **	U	Issue No.	31
LM End	3.44	Issue Type +	Ma	Location *	LS
Category	Earthen Levee			GPS Latitude/Longitude	
				Start	End
Item	Animal Control			36.929093 °	36.929093 °
				-120.340920 °	-120.340920 °
DWR ID	DWR_NA0010_18_f_2019_31				
Comment Code					
A3 : No rodents visible, but rodent burrows visible; need to backfill and compact or grout burrows.					
Inspector Comment

View of rodent burrows in the landside slope. (Fall 2019)

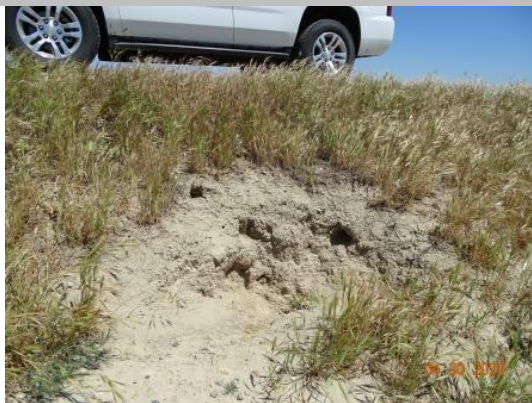
Photo 1 of 1 : SP_2020_NA0010_137_47_20200512_00034.jpg

LM Start	3.73	Rating **	U	Issue No.	47
LM End	3.73	Issue Type +	Ma	Location *	LS
Category	Earthen Levee			GPS Latitude/Longitude	
				Start	End
Item	Animal Control			36.924969 °	36.924969 °
				-120.339407 °	-120.339407 °
DWR ID	DWR_NA0010_18_s_2020_47				
Comment Code					
A3 : No rodents visible, but rodent burrows visible; need to backfill and compact or grout burrows.					
Inspector Comment

Large rodent burrow in the landside slope. (Spring 2020)

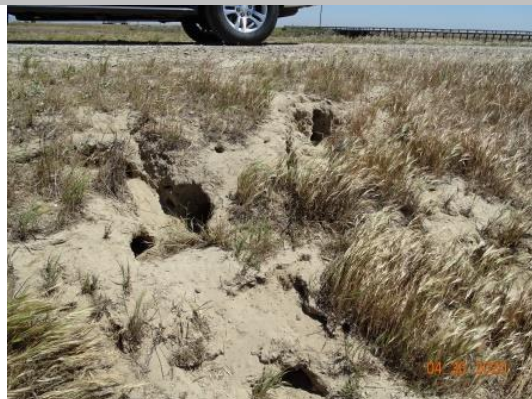
Photo 1 of 1 : SP_2020_NA0010_137_14_20200512_00035.jpg

LM Start	7.39	Rating **	U	Issue No.	14
LM End	7.53	Issue Type +	Ma	Location *	LS
Category	Earthen Levee			GPS Latitude/Longitude	
				Start	End
Item	Animal Control			36.874479 °	36.872503 °
				-120.319831 °	-120.319438 °
DWR ID	DWR_NA0010_18_f_2017_14				
Comment Code					
A3 : No rodents visible, but rodent burrows visible; need to backfill and compact or grout burrows.					
Inspector Comment					
There are several rodent holes noted along the landside slope in this area.

View of rodent burrows in the landside slope. (Spring 2020)

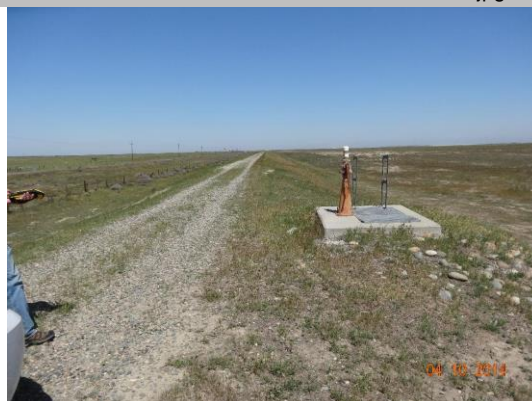
Photo 1 of 3 : UCIP_SP_2020_36843_67202.jpg

Comment Code						
Inspector Comment						
DS_ID:19930 FS_ID:36843 EP_NO: N/A Repair Type: Non-Urgent Crossing Status: Found UCIP Comments: 04/10/2014 CMP crossing is distorted on waterward side. Debris scattered on landward side. Sediment deposit inside crossing visible from landward side. Recommend removing debris from landward side. (DWR UCIP - O. Magana) FIELD_STRUCT_DESC: 42-inch reinforced concrete gravity irrigation pipe through the levee, 19 feet below the crown. Gate structure on the waterside (WS) shoulder. Pipe section on the WS is corrugated metal. Pipe section on the landside (LS) is reinforced concrete. (Plans to install a 42-inch gravity-flow concrete pipeline through the left bank levee of the Eastside Bypass to divert bypass waters for irrigation purposes authorized under Permit No. 13548, 1983 - New Stone Water District). [Additional Reference(s): DWR Levee Log, 2002]. FS Date: 4/10/2014

Overview of levee crown at crossing--slide gate inside concrete box located on waterward shoulder.

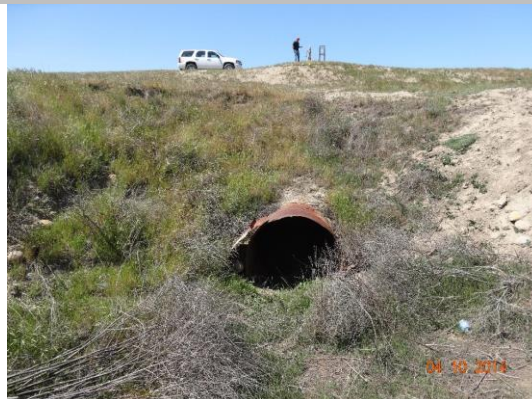
Photo 2 of 3 : UCIP_SP_2020_36843_67205.jpg

Pipe section distorted on waterward side.

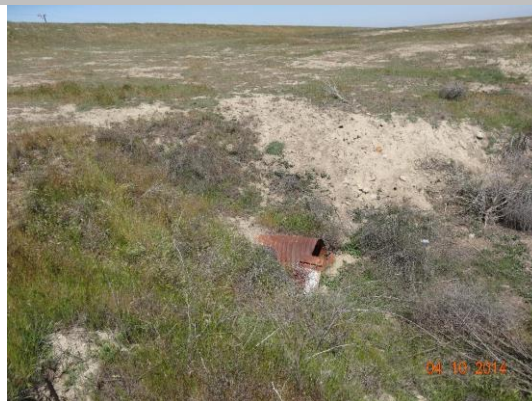
Photo 3 of 3 : UCIP_SP_2020_36843_67200.jpg

CMP section visible on waterward side.

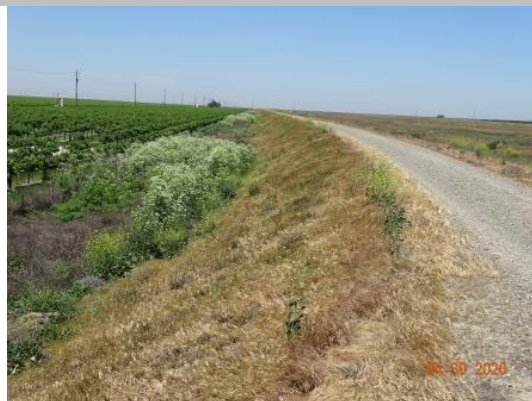
Photo 1 of 1 : SP_2020_NA0010_137_43_20200512_00036.jpg

LM Start	8.26	Rating **	U	Issue No.	43
LM End	8.55	Issue Type +	Ma	Location *	LS
Category	Earthen Levee			GPS Latitude/Longitude	
				Start	End
Item	Vegetation			36.862094 °	36.857892 °
				-120.317409 °	-120.316656 °
DWR ID	DWR_NA0010_18_s_2020_43				
Comment Code					
V1 : Control annual grass and weeds on the levee slopes and easements.					
Inspector Comment

View of the landside slope looking downstream. (Spring 2020)

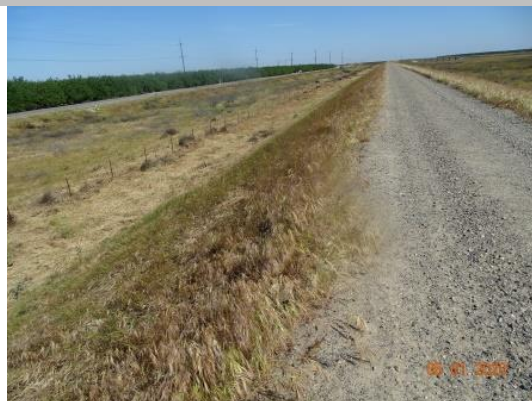
Photo 1 of 1 : SP_2020_NA0010_137_58_20200512_00037.jpg

LM Start	9.05	Rating **	U	Issue No.	58
LM End	9.49	Issue Type +	Ma	Location *	LS
Category	Earthen Levee			GPS Latitude/Longitude	
				Start	End
Item	Vegetation			36.850654 °	36.844339 °
				-120.316342 °	-120.316088 °
DWR ID	DWR_NA0010_18_s_2020_58				
Comment Code					
V1 : Control annual grass and weeds on the levee slopes and easements.					
Inspector Comment

Looking downstream along the landside slope. (Spring 2020)

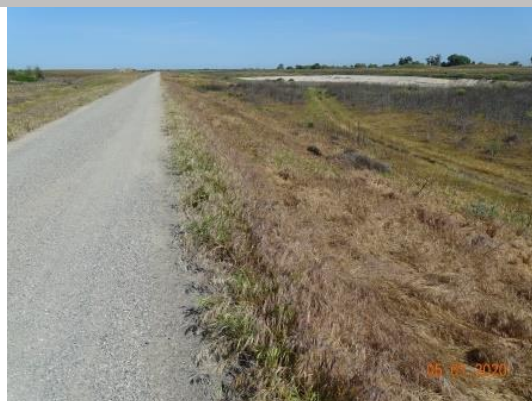
Photo 1 of 1 : SP_2020_NA0010_137_50_20200512_00038.jpg

LM Start	9.05	Rating **	U	Issue No.	50
LM End	14.95	Issue Type +	Ma	Location *	WS
Category	Earthen Levee			GPS Latitude/Longitude	
				Start	End
Item	Vegetation			36.850654 °	36.778256 °
				-120.316342 °	-120.289239 °
DWR ID	DWR_NA0010_18_s_2020_50				
Comment Code					
V1 : Control annual grass and weeds on the levee slopes and easements.					
Inspector Comment

View of the waterside slope looking downstream. (Spring 2020)

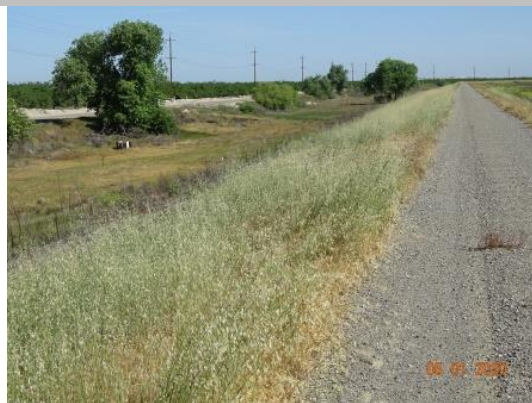
Photo 1 of 1 : SP_2020_NA0010_137_54_20200512_00039.jpg

LM Start	10.35	Rating **	U	Issue No.	54
LM End	12.46	Issue Type +	Ma	Location *	LS
Category	Earthen Levee			GPS Latitude/Longitude	
				Start	End
Item	Vegetation			36.834972 °	36.807415 °
				-120.306263 °	-120.308602 °
DWR ID	DWR_NA0010_18_s_2020_54				
Comment Code					
V1 : Control annual grass and weeds on the levee slopes and easements.					
Inspector Comment

View of vegetation along the landside slope looking downstream. (Spring 2020)
